# Taking a Shot in Richmond

By: Tonia Jurbin, P.Eng.

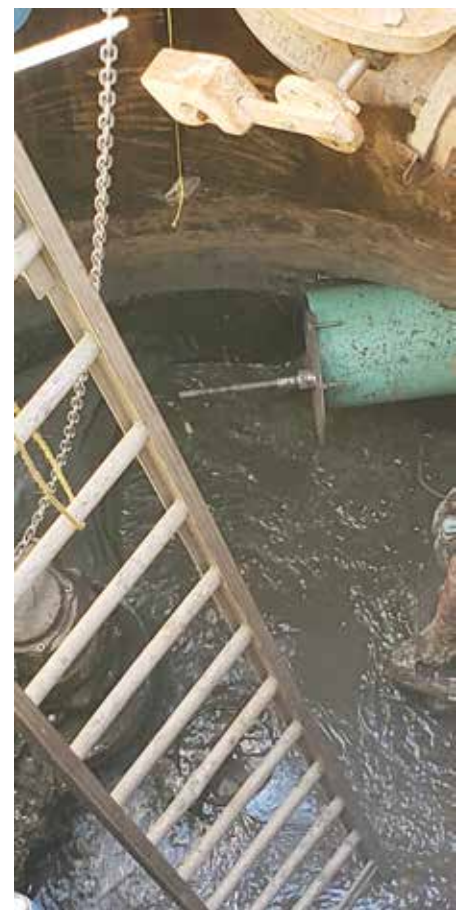
*Installed 750mm pipe section with ready rod 'clamp'. Note 'awkward' position of pipe entering pump station*

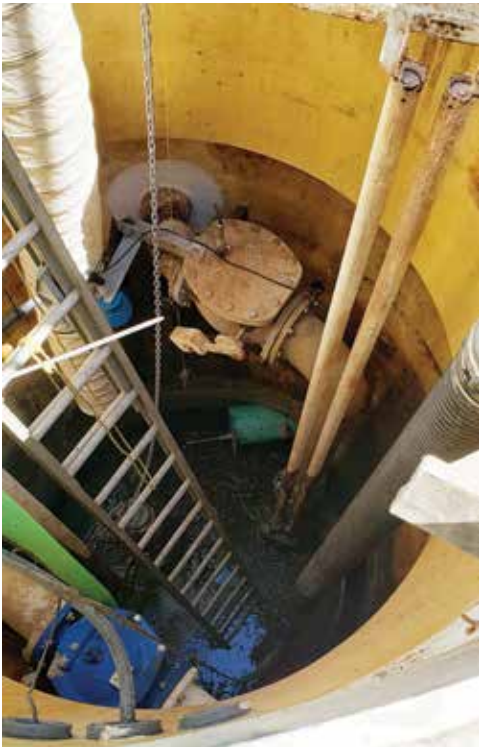
*Depth of the repair work about 5 metres down*

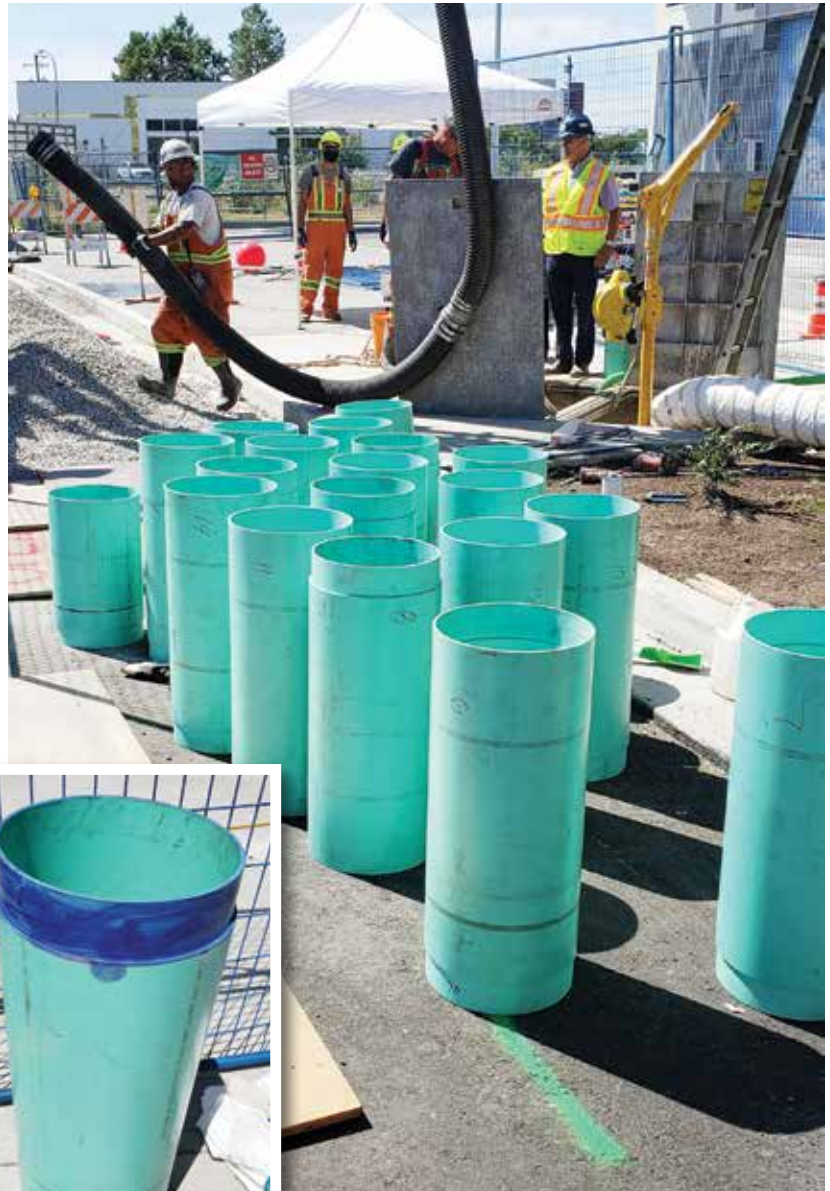
*Custom 750mm PVC sections - note the modified bell and spigot joint*

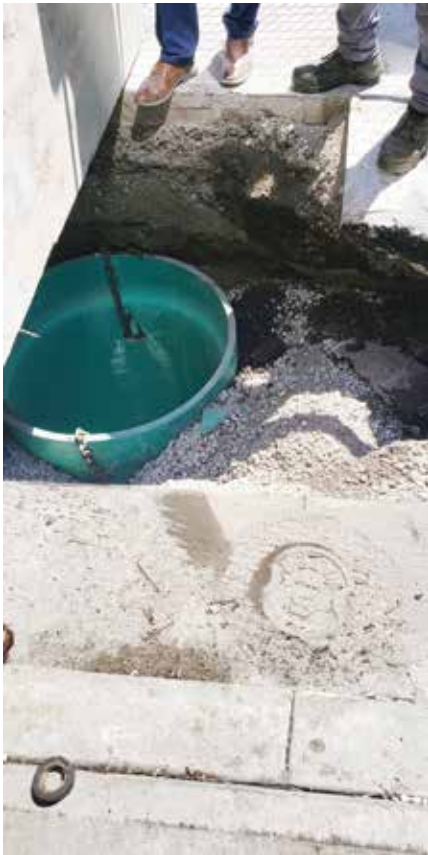
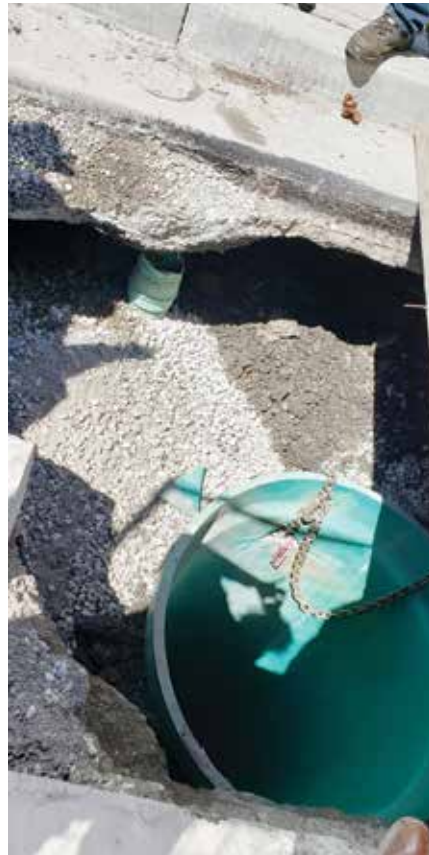
The second reason for the keeping the site shut down for further evaluation was the discovery that somewhere between 5m<sup>3</sup> - 9m<sup>3</sup> of material had infiltrated the breach and migrated back through the breached pipe into the pump station. This unanticipated movement of fill explains the large sinkholes shown in the attached photographs. Although this material was easily removed from the pump station the concern is the alarming volume of material migrating below the surface possibly creating risk to the other services in the immediate vicinity of the breach and

*Sinkhole caused by migrating fill*

more sinkholes in the area. Once the areas at risk are identified they will be prioritized and densified before further repair attempts can be carried out'.
