# What's Under That House?

## What's Under That Graveyard?

By: Tonia Jurbin, PEng

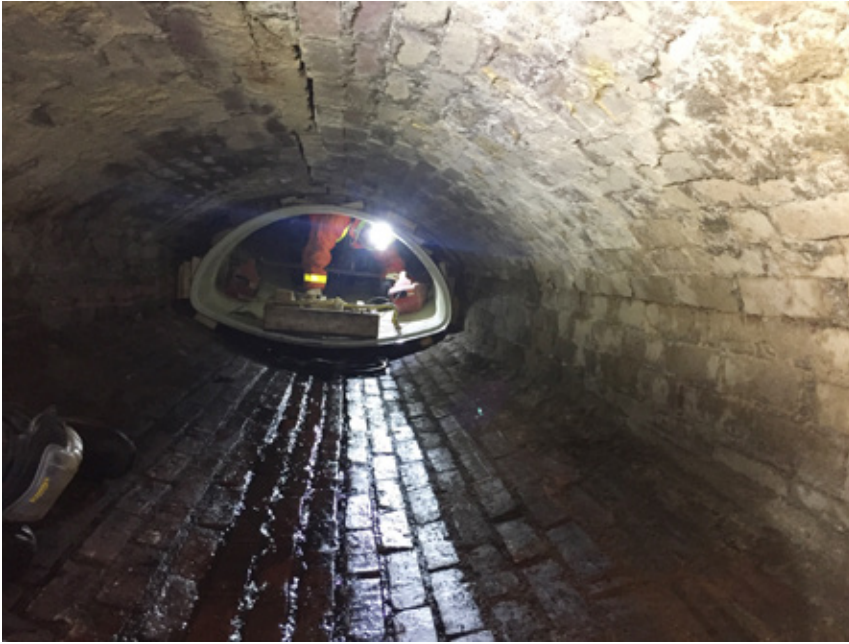
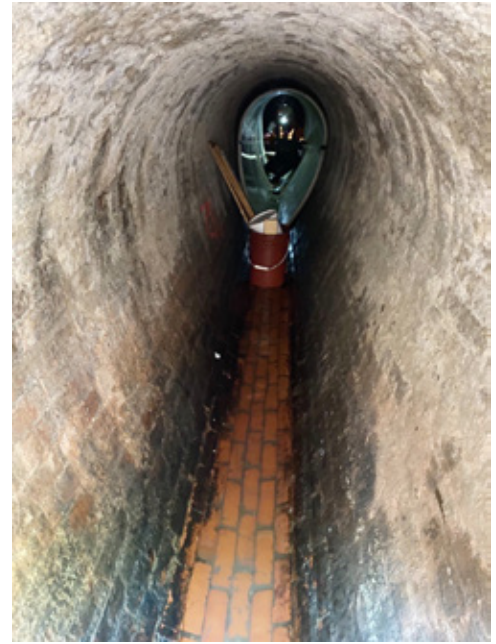
*GRP liners conform to the unique shape of the existing pipe*

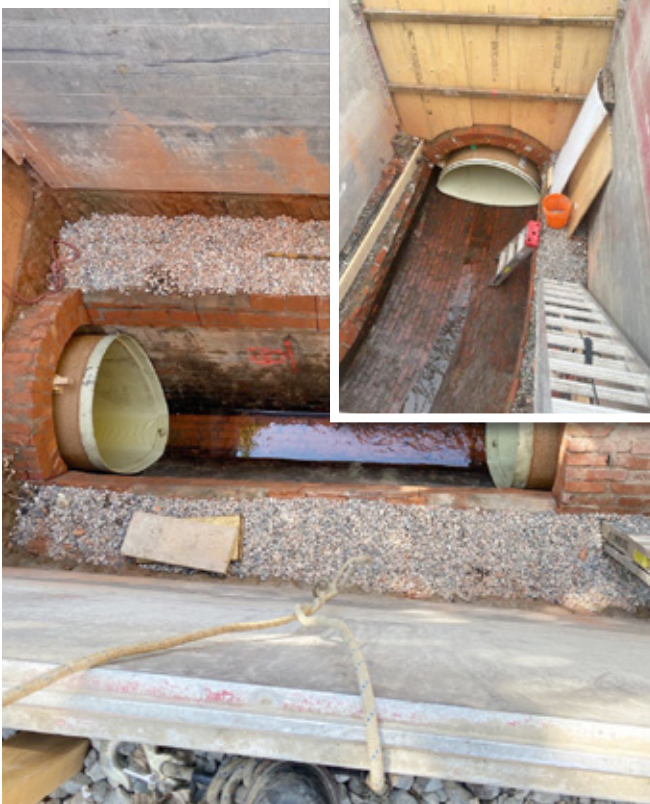
*Each 2.4m segment of GRP was carefully pushed together for a watertight joint*

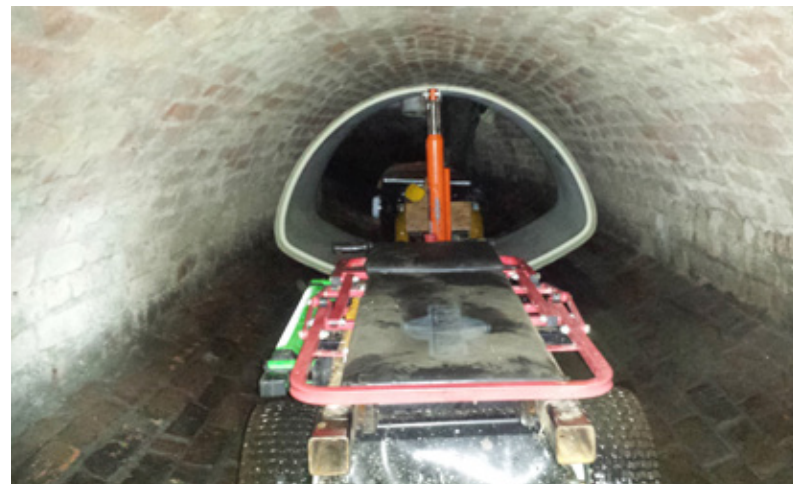
*Each GRP segment was maneuvered into place using an electronic motorized cart*

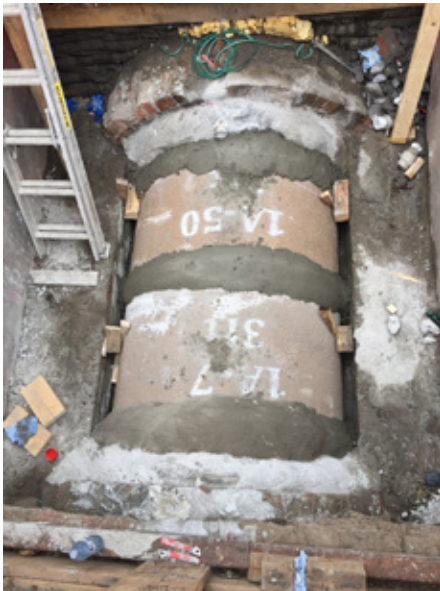
Each seam had internal gasket and external seal

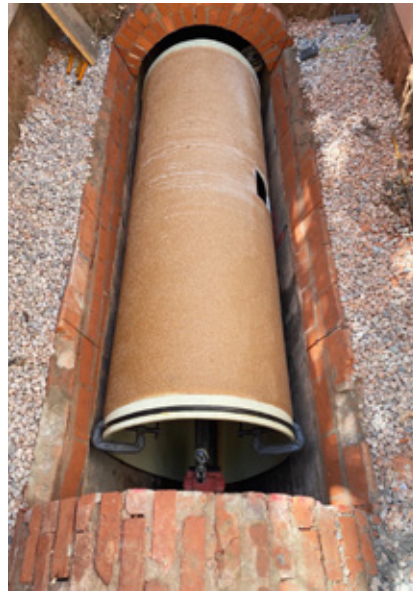
GRP segments are treated with bonded graded aggregate material to enhance adhesion to the annular grout

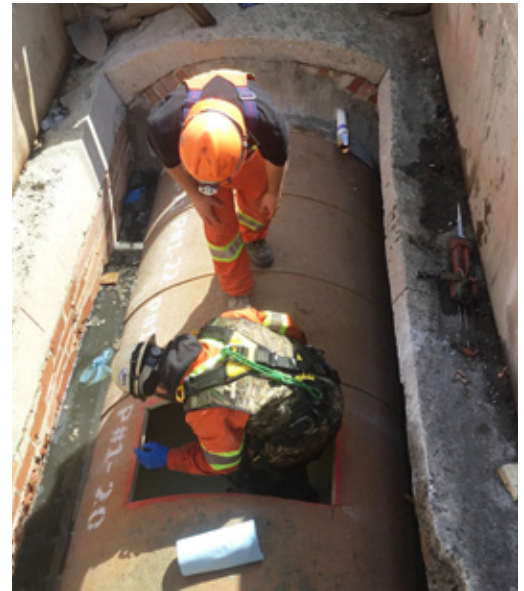
Man entry was necessary prior to grouting

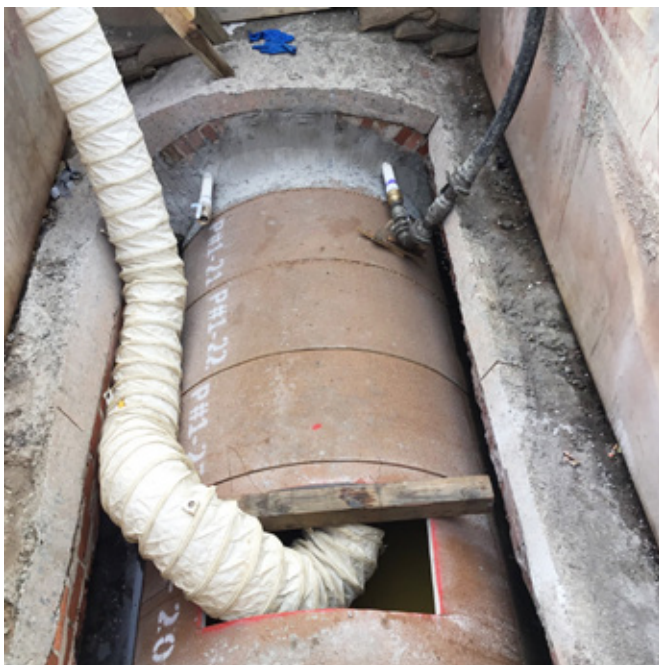
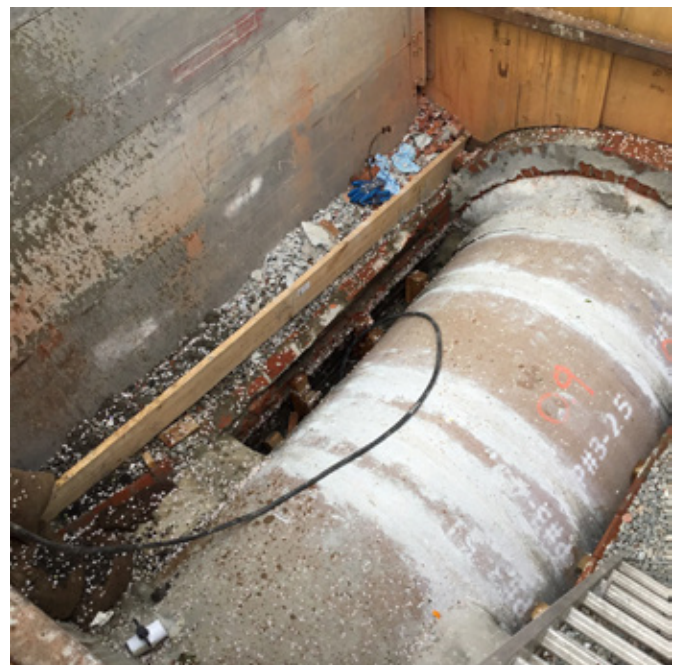
Annular grouting completed the construction process

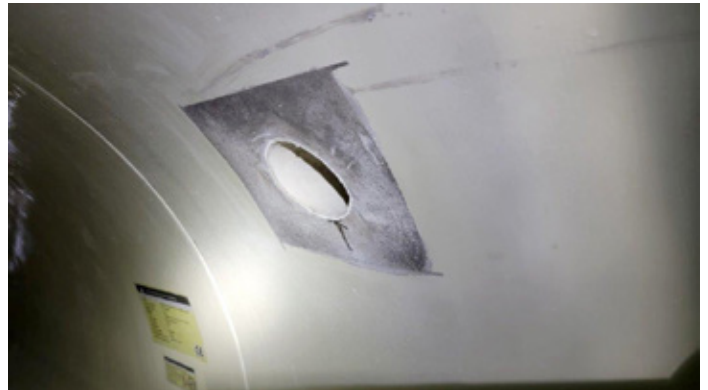
*Laterals were located and cut*
