**North American Society for Trenchless Technology (NASTT)
NASTT's 2023 No-Dig North Show**

**WA-T1-06
Pre-Chlorinated Pipe Bursting in the North Okanagan**

David O'Sullivan, PW Trenchless Construction Inc, Surrey, British Columbia
Tonia Jurbin, P. Eng. (retired) Writer & Editor, Greater Vancouver, British Columbia

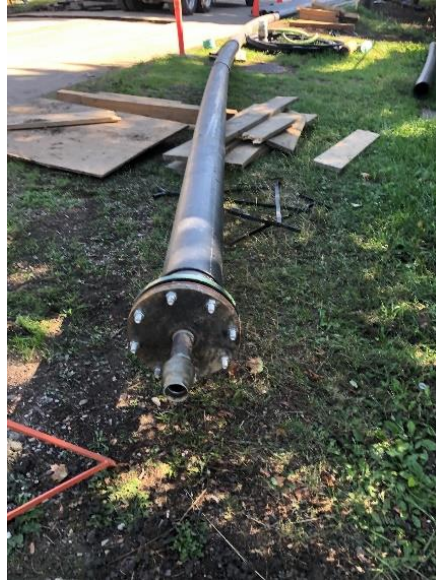
All the pre-chlorinated water mains were tested above ground for pressure, super chlorination and bacterial prior to installation. It was tested as if it were in the ground, rather than on the ground, as per AWWA C651-14, see Figure 2. After the installations, a standard pipe flushing operation was done with all the flushing water discharged safely, and normal reconnections were made to the existing water pipes. By testing and chlorinating the pipe before installation in this manner, the pipe was returned to service immediately as opposed to the week that would have been required for testing and chlorination using conventional methodologies. This also allowed the bypass to be removed a week earlier, restoring regular service to the properties.

Figure 2 -Pressure tested pipe ready for installation.

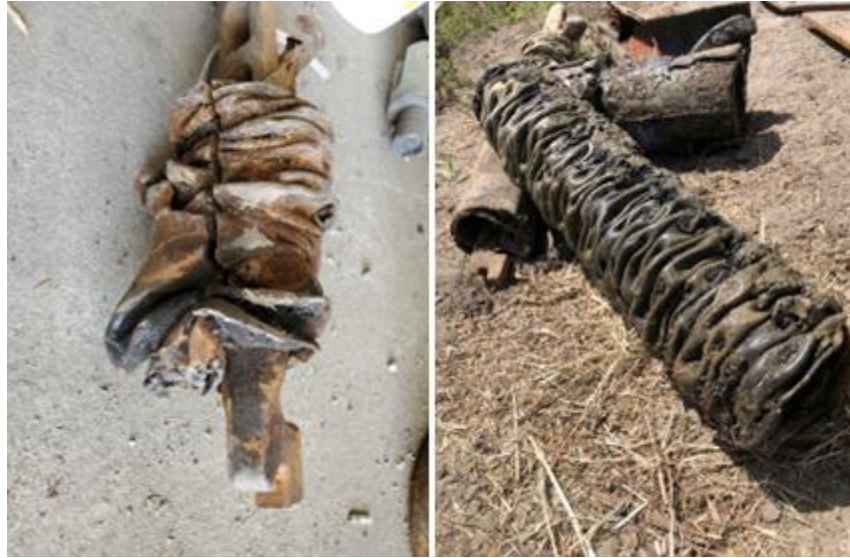
The trouble started for the project right out of the gate. Turns out that the existing very uncommon 1/8" thick spiral steel pipes from the 1940's were quite different from today's standard steel pipe and were particularly challenging for the pipe bursting application, at least with the standard equipment the contractor had. Rather than splitting the pipe the bursting head crushed and crumpled the pipe in front of it as demonstrated in Figure 3. Pipe bursting is a process where the existing pipe is broken or split but *left in place* while the new pipe is pulled. Pipe bursting is not piping extraction, extraction requires far more energy and is only used in road crossings and lengths of 20m to 50m.

Figure 3 - Original bursting head crumpling rather than splitting the existing pipe.

The bursting of this steel pipe required different bursting tools and different methodologies, which the construction team needed time to review to find the right solution before the work could continue. The first 5 burst attempts involved research and collection of data; thus, results were carefully recorded. The outcomes were that this very thin-walled steel pipe needed careful attention to keep the splitting process going and not start a crumpling event. PW had to design a new bursting head better suited to the thin spiral steel pipe. If this new head were too big the steel pipe would not split but crumple, if the new bursting head was too small the steel pipe rebounded and gouged the newly installed HDPE pipe. The new bursting head was designed so that even if the steel pipe rebounded during the splitting process, it was still far enough from the new pipe to not cause damage. Eventually, an innovative design was decided on and a bursting head was manufactured in the lower mainland. Figure 4 shows the different options for bursting heads.

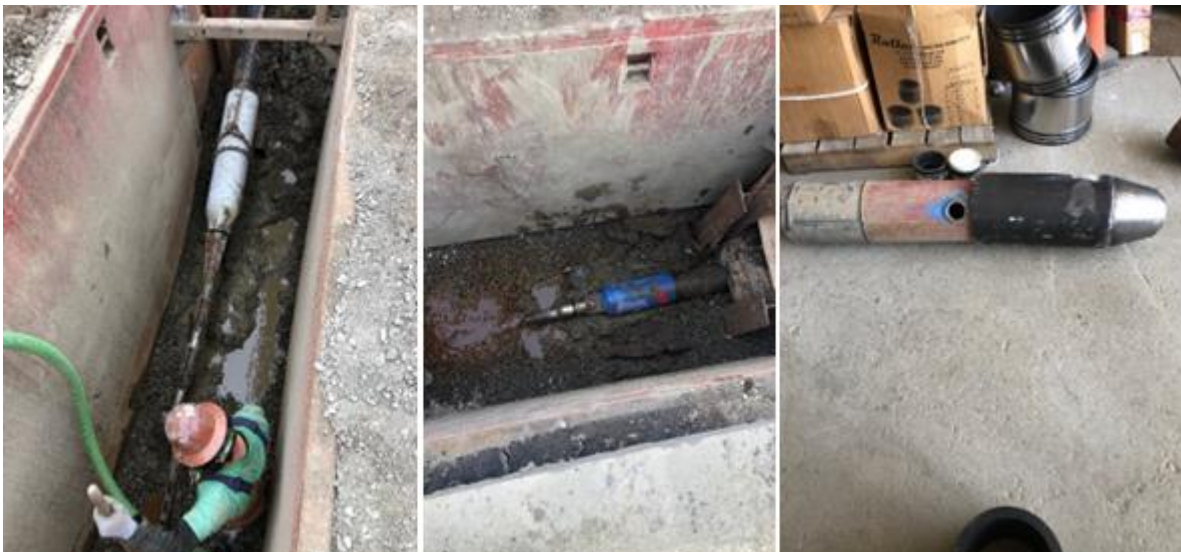
Figure 4 - The three bursting head options; the white head is a manufactured supplied head that was too large, the blue head is an HDD pulling head which was the same OD as the host pipe and too small, the black head was PW's design which worked.

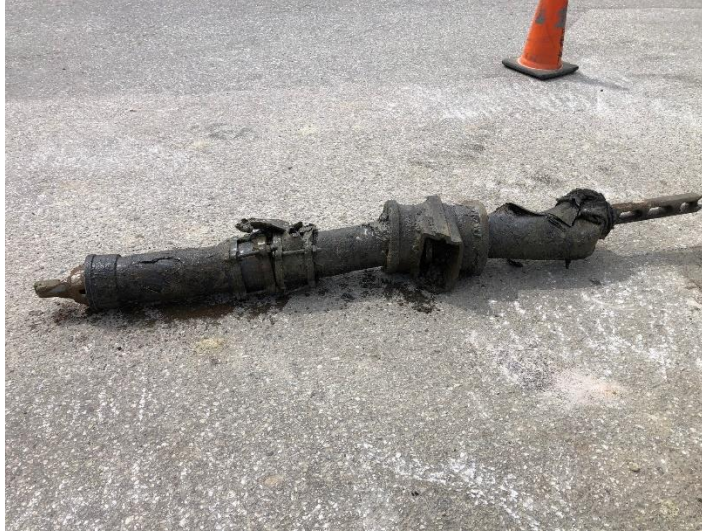
- A wealth of information exists with long-time employees and while these were recollections that cannot be included in contract documents as fact, they are very useful when rehabilitating existing pipes. Where possible it can be very useful to interview long-term employees with some corporate memory, especially with regards to abandoned services which may not be recorded on as built's, Figure 5 shows such an example.

Figure 5 - An example of old infrastructure encountered that might have been shared by a long-time operations employee.
