terminal situation

By Correspondent Tonia Jurbin

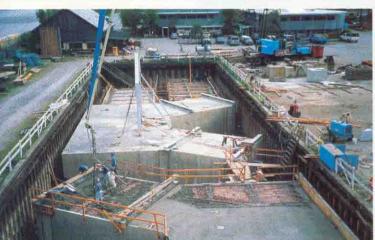
Pre-fabricated concrete pontoons and wingwalls were built in dry-dock and later shipped to their new locations.

Different shape structures were built to accommodate different-shaped vessels.

The pontoons are cast-in-place concrete slabs and walls with internal styrofoam or polystyrene filled billets. The volume of styrofoam ranges from about 130 to 170 m³,

The pontoon at Earls Cove has about $130 \, \text{m}^3$. The depth of these pontoons range from $2.7 \, \text{m}$ to $3.1 \, \text{m}$. The pontoon at Earls Cove is $2.8 \, \text{m}$ deep.

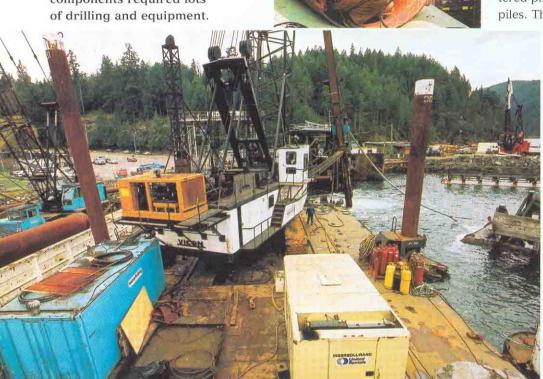
A welder works on a pile and steel cage combination.

Replacing older wooden piles with new concrete components required lots of drilling and equipment.

Because there is no overburden at this site, the vertical piles were set in 2 m deep, 1168 mm dia rock sockets. The holes were located, drilled and inspected and the piles were set and the annulus filled with grout. After that, 711 mm dia pin piles were drilled another 5 m deeper than the bottom of the 1067 mm vertical piles.

Reinforcing steel cages were dropped into the pin and the vertical piles. Holes were punched in the battered piles and welded to the vertical piles. The whole assembly was filled
