BC Hydro Undertakes Landmark Transmission Project

by Tonia Jurbin • Contributing Editor

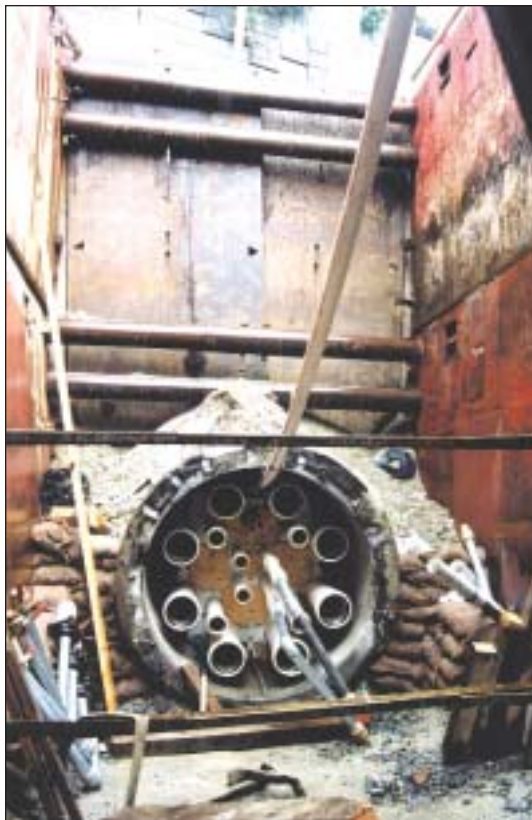
Top: The exit pit shows the completed tunnel with all carrier pipes. A grout tube is also shown. **Bottom:** Massive concrete manhole/vault being lowered into the ground.

Once completed, the ducts were pulled through the tunnel; eight 8-inch ducts for the transmission cable, four 4-inch ducts for cooling fluid, and four 3-inch ducts for future fiber optic cables. About 100 yards of grout was pumped into the inside annulus once all the ducts were in place.
