# Delicate blasting on Highway 99

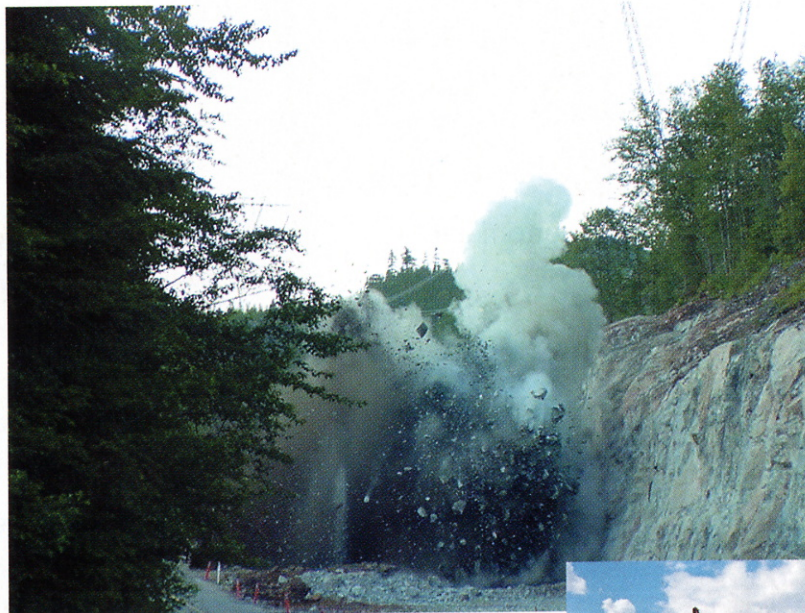
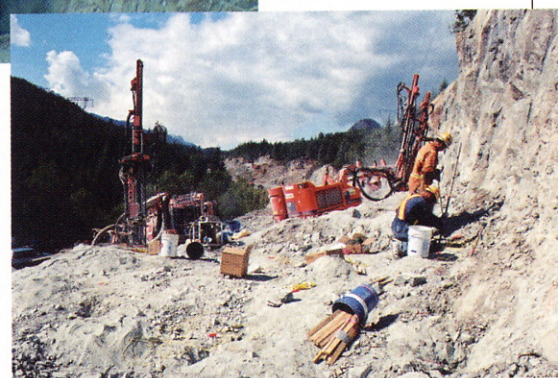
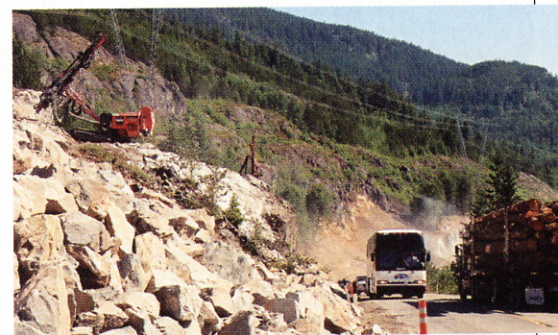
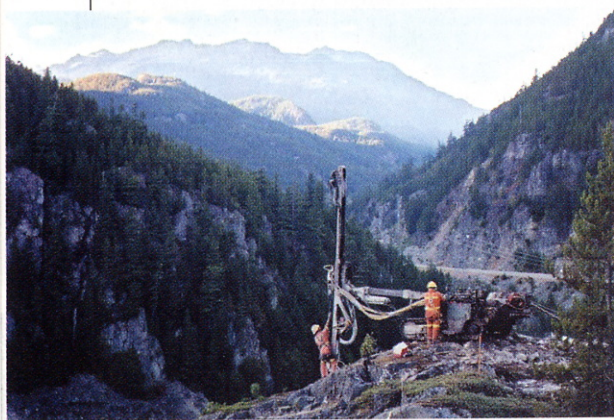
The natural internal fractures of the rock necessitated controlled blasting techniques.

"Wall-control" blasting, or "smooth-wall" blasting methods were used on this job. The blast is designed to just crack the rock along the back wall — without breaking it — milliseconds before the rest of the rock is blasted.

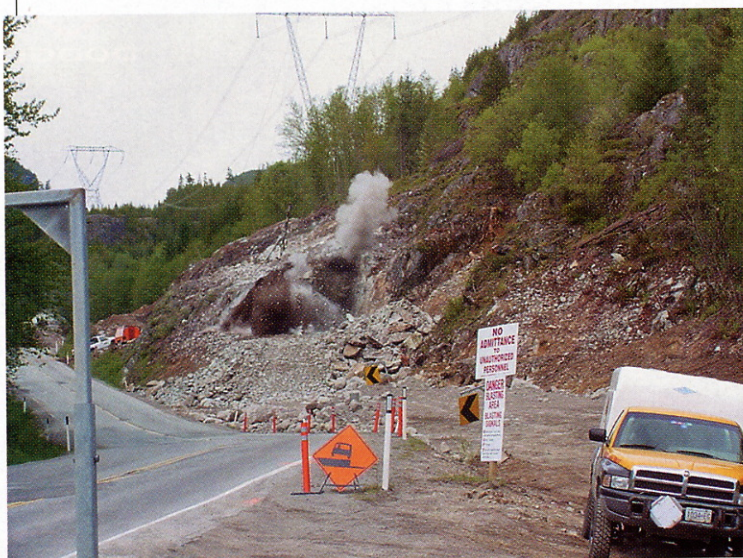
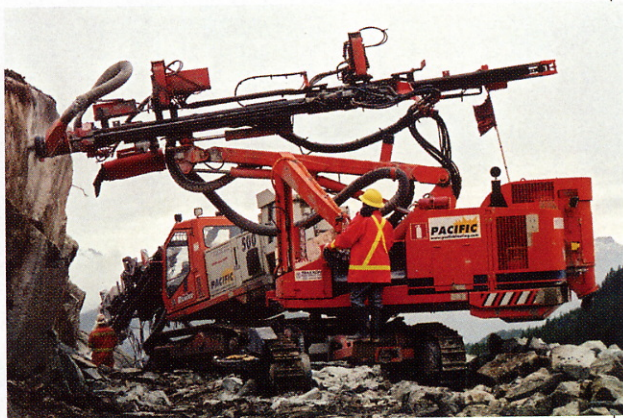
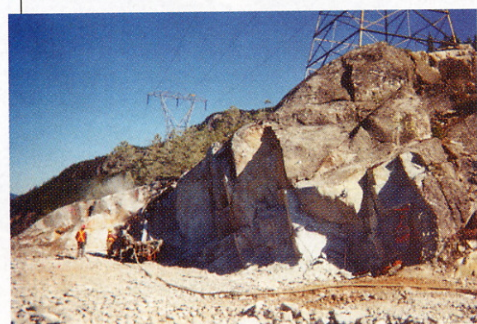
The work was carried out over two windows to accommodate the ski season.

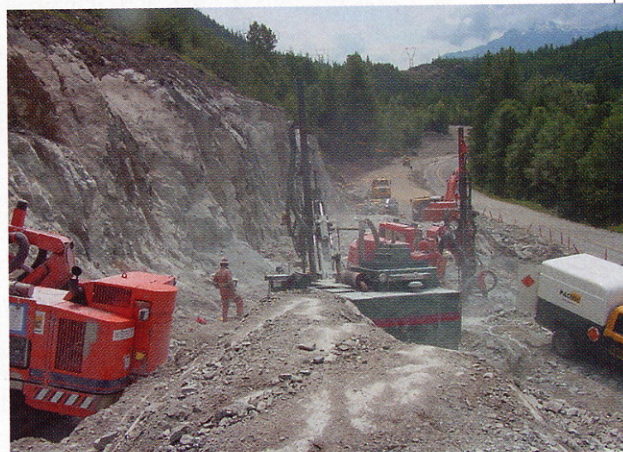
The blasting contract included all the drilling and blasting, rock-bolting, meshing and shotcrete work required.
