Pilings solve tank settl

Helical piling technology meant that this B.C. shop was able to repair settlement problems without shutting down.

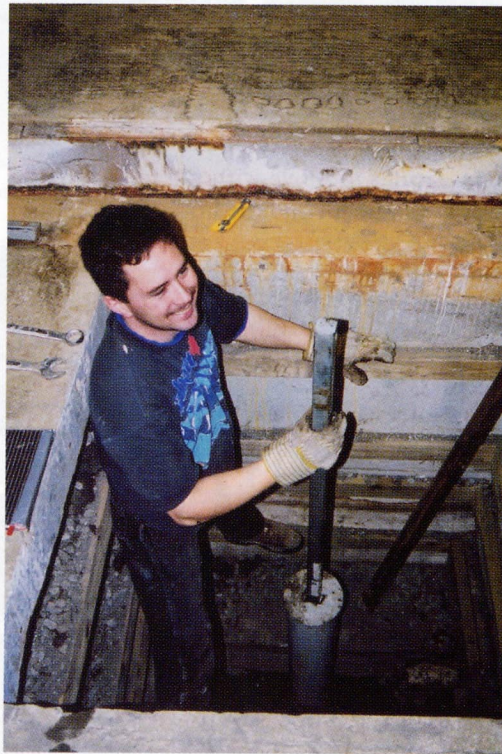
Six holes had to be hand-excavated and shored around the perimeter of the tank.

The piles were then mechanically attached with lifting brackets to the bottom of the tank footing, which is about six ft. below the floor of the plant. A total of six holes had to be hand-excavated and shored along the perimeter of the tank. The holes were four ft. sq. by about six ft. deep.

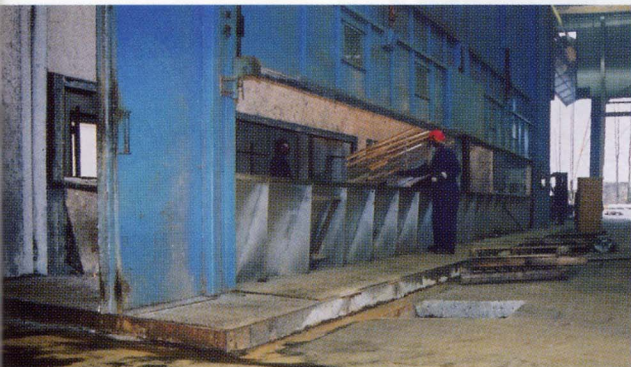
Huge tank stayed in operation during project.
