**North American Society for Trenchless Technology (NASTT)
NASTT's 2023 No-Dig North Show**

WA-T1-04

Live Sliplining in Surrey

David O'Sullivan, PW Trenchless Construction Inc, Surrey, British Columbia
Tonia Jurbin, P. Eng. (retired) Writer & Editor, Greater Vancouver, British Columbia

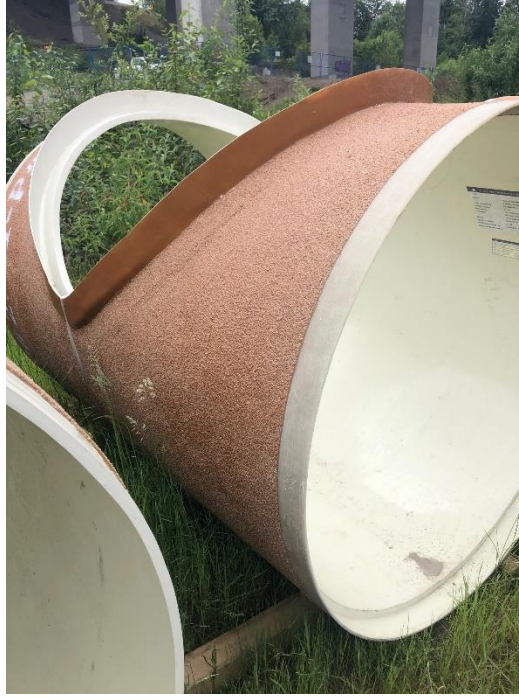
Figure 1 - GRP Liner - Note the bonded brown aggregate outside and smooth inside

The material chosen for this project was supplied by Channeline International - GRP Structural Lining Systems. It has a 1.5mm thick smooth corrosion resistant inner lining. Having a smaller overall inside diameter of 1,375mm, the assumption is that because there is a smaller cross-sectional area that the capacity will decrease. In this case, when comparing the smooth surface of the GRP to the rougher surface of the corroding concrete that creates turbulence the capacity of the new pipe will in fact increase. Of course, the existing flow capacity was also diminished by the four decades of accumulated sediment in the existing pipe. The GRP liner outside diameter of 1,420mm is treated with a bonded graded aggregate to enhance adhesion to the annular grout required after the liner installation is complete. Figure 1 shows the smooth inside and the rough outside of the GRP liner.

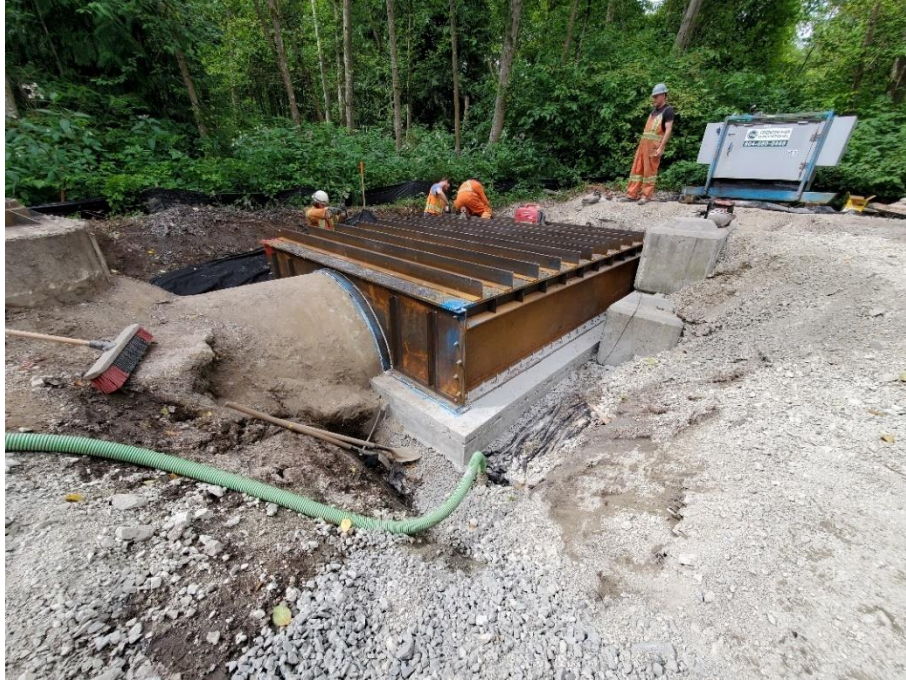
Figure 2 - Water tight flow control chamber with lid that can be removed or replaced in under 30 minutes.

No cuts into the existing pipe were allowed until these chambers were fully operational. The watertight chambers were designed to withstand surcharges of up to 7psi with lids that could be removed and replaced in 30 minutes. The chambers were large enough to allow a worker to work from inside the chamber while cutting the existing pipe. The sealing chambers were installed in 2020 but the pipe installation work could not begin until the spring of 2021. Figure 2 shows the flow control chamber.

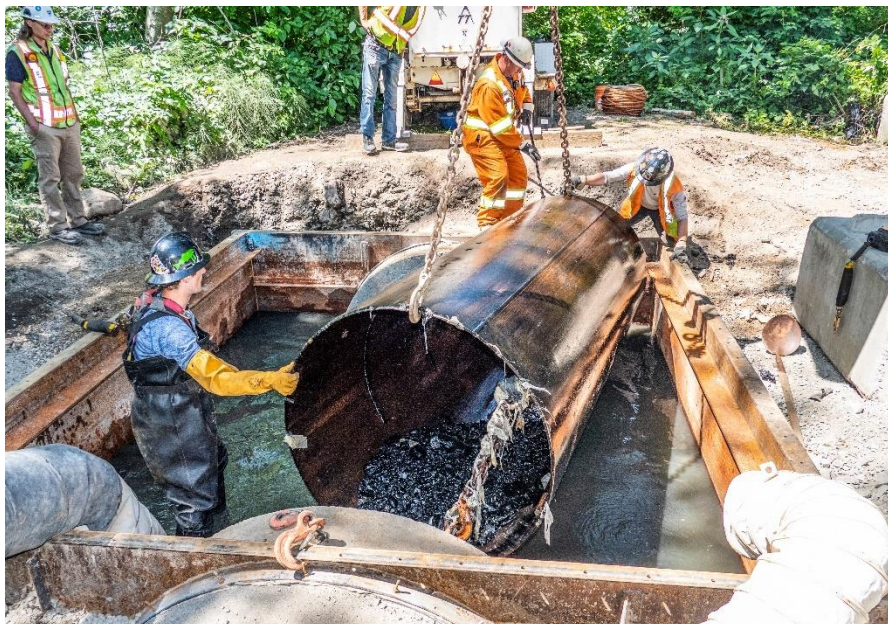
Figure 3 - Dredging and debris removal

As the existing pipe is about 50 years old the invert had a considerable accumulation of deposits ranging in size from silt to small rocks that had to be dredged. Debris from previous repairs was also discovered during the dredging all of which had substantially reduced the available cross-sectional area restricting the flow, see Figure 3. During the dry weather, the flows varied throughout the day with the morning rush from the Fraser Valley hitting the site around mid-morning and moderating later in the afternoon. There were four main sections of pipe on this project that all required slightly different dredging techniques and preparation.

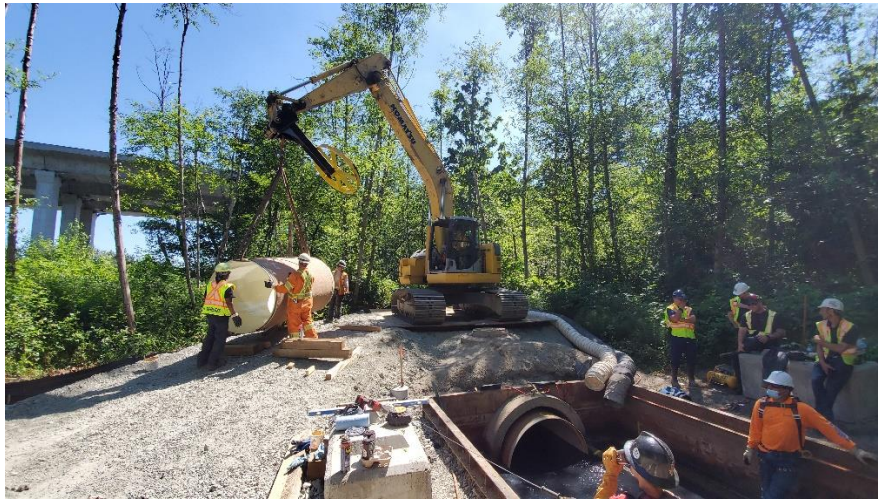
Figure 4 - an insertion pit with next pipe ready to go in.

Section 1 starting at the east extent of the project was a 15m long straight section from a sewage receiving chamber to an intermediary pit. The 15m of pipe was pushed from the intermediary pit east to the chamber. Figure 4 shows an insertion pit.

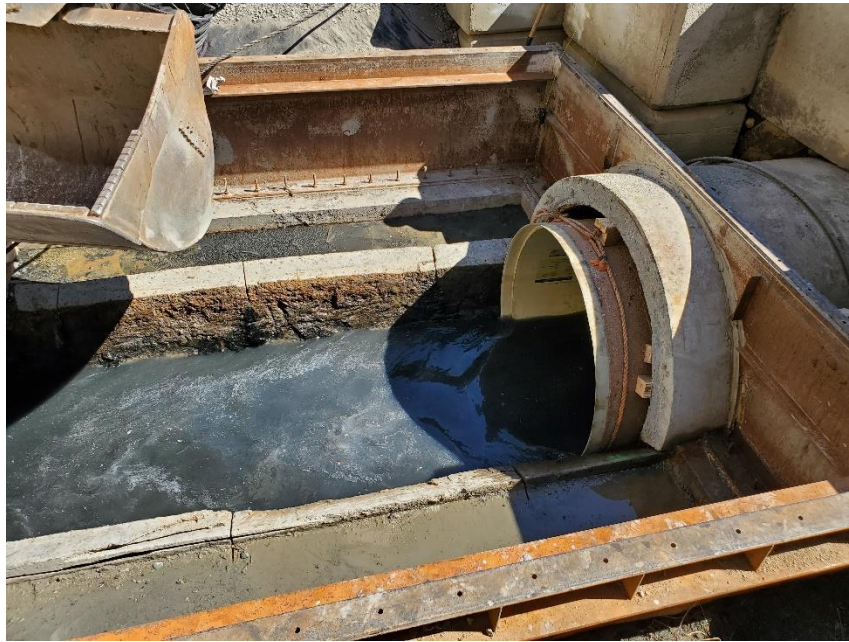
Figure 5 - The new liner in place during a moderate flow

Once the chambers were in place and the existing pipe cleaned out the installation process was straightforward. The 2.4m standard sections were lowered into the chamber and pushed towards the direction of the installation, then held in place while the next piece was brought in. The GPR pipe sections were lowered into the work area with the upstream end of the section slightly lower than the downstream end so that when the flow pushed on the pipe it would push the pipe down rather than up. Once the next piece was lowered it was held in place and then pushed into the bell of the previous section of GPR pipe section. For this project the pipe was placed directly on the invert of the existing pipe, no spacers were used. Finally, the total pipe string was pushed home as shown in Figure 5.
