**North American Society for Trenchless Technology (NASTT)  
NASTT's 2023 No-Dig North Show**

**WM-T1-05, The use of trenchless to rehabilitate the sewers of Richmond**

David O'Sullivan, PW Trenchless Construction Inc, Surrey, British Columbia  
Tonia Jurbin, P. Eng. (retired) Writer & Editor, Greater Vancouver, British Columbia

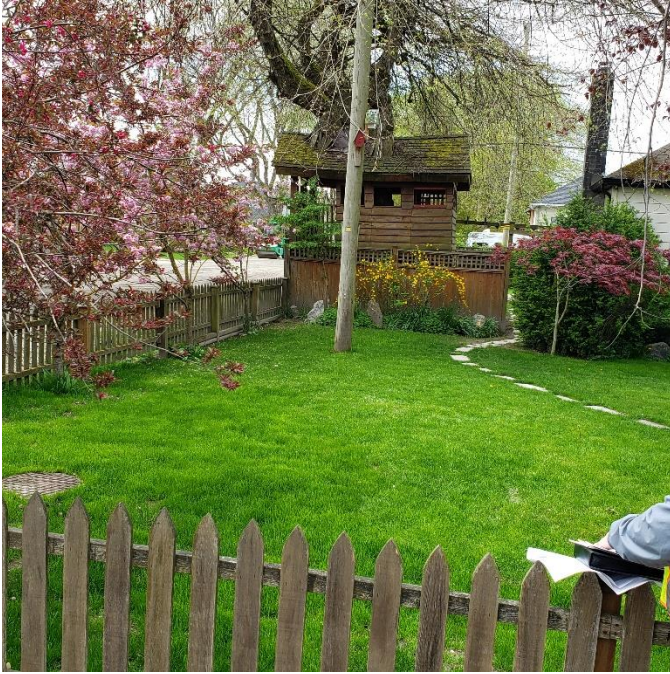
**Figure 2. Shows the alignment of sanitary sewer between the manhole and middle of treehouse**

Some trees had to be removed or relocated. Some immature trees were removed, stored, and cared for at the City nursery and later replanted. On one such property a tree was relocated a few feet away from the immediate work around the manhole in the residents' front lawn that happened to be City property. This tree is shown along the left edge of Figure 2.

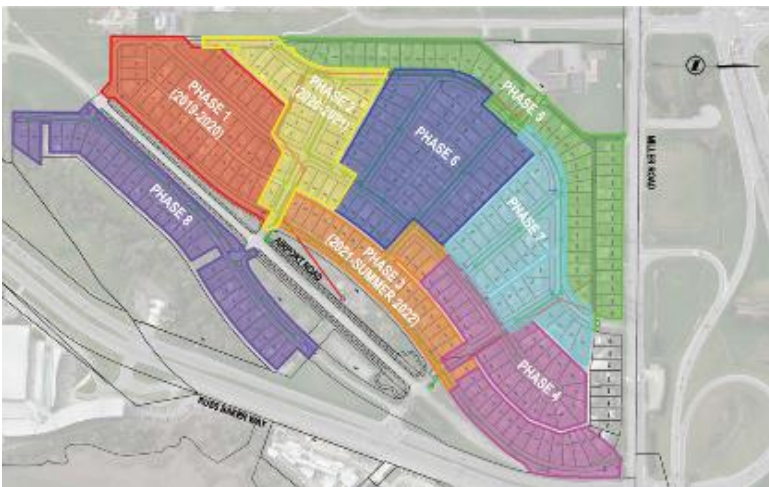
**Figure 3. Burkeville Drainage, water main and sanitary sewer upgrades phasing**

This pipe bursting project is only Phase II of an VIII Phase renewal program for all the infrastructure including water mains, roads, drainage, and the sanitary sewers which are the focus of this paper. All the trenchless work on this project, including cast in place pipe lining (CIPP), horizontal directional drilling (HDD), pipe jacking and the pipe bursting to minimize disruption of ‘private property’ is being installed by specialty contractors. PW Trenchless is the contractor carrying out the pipe bursting for the sanitary work described in this paper. All the conventional infrastructure upgrades are carried out by City crews. Figure 3 shows the overall scope of this undertaking.

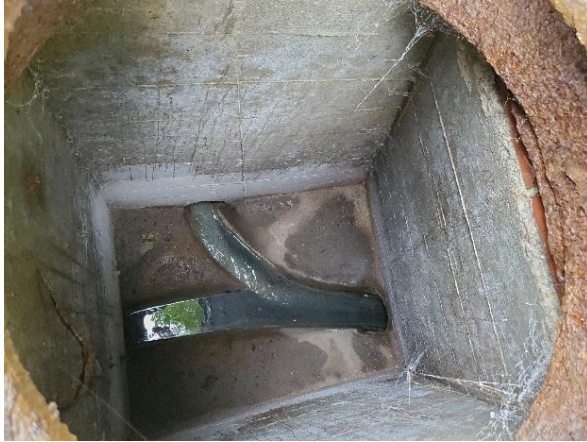
Figures 4. Typical manhole ready for reuse

Also fortunately, there was a budget allowance for the manholes built in the 1940's and 1960's to be rehabilitated. All the manholes were all pumped out, cleaned, inspected and found to be acceptable. While the pipes were full of leaks and roots, the manholes required minimal modifications, only the ladder rungs were replaced. This demonstrates the mismatching of the life spans of materials. The concrete manholes can have a life expectancy in excess of 100 years not so for the vitrified clay pipes. In these soil conditions the clay pipes proved to be susceptible to cracking and joint separation. The use of the existing manholes does reinforce the benefit of staying within the existing alignment, a common benefit of most trenchless methods. An open cut solution might have required a new alignment abandoning both the poor pipe and good manholes. Figures 4 shows the condition of a typical manhole and Figure 5 shows a typical entry / exit pit, only 6 of which were needed on this Phase of the project.

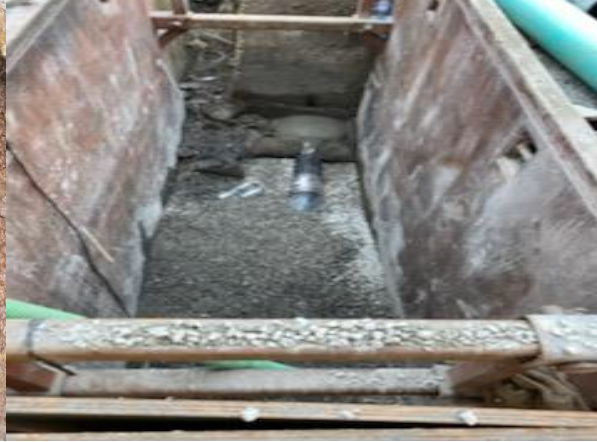
Figure 5. Typical entry/exit pit, only 6 were needed for Phase II
