# PIPE BURSTING - WHAT COULD GO WRONG?

By Tonia Jurbin

The pipe bursting on the largest of the three sites is described in this case study.

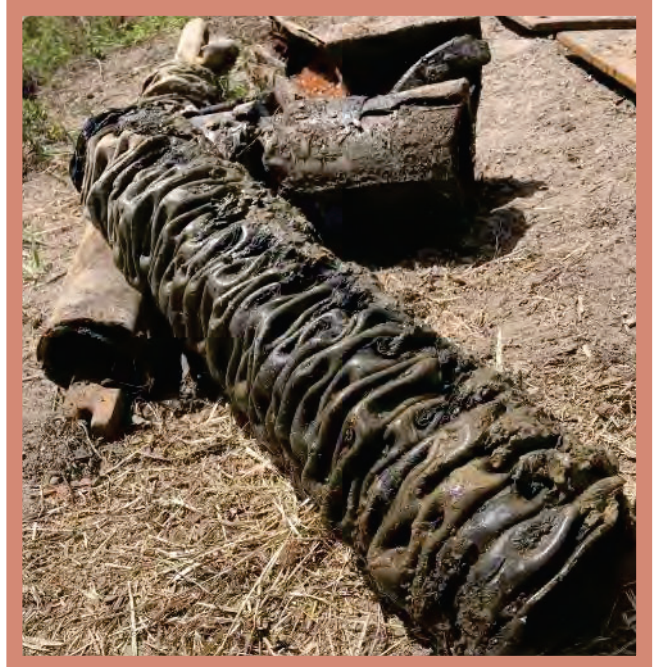
The first five bursting attempts were mostly experimental, the equipment, processes and results were carefully recorded. The standard bursting head PW brought to the site turned out to simply crumple the steel pipe in front of the bursting head rather than splitting it.

This thin-walled steel pipe needed careful attention to keep the splitting process going and not start a crumpling event.

Original bursting head crumpling rather than splitting the existing pipe.

If the head was too big (Photo on Pg. 20) the steel pipe would not split but crumple, if the head was too small the

steel pipe rebounded and gouged the new pipe. PW had to design a new “Goldie Locks” bursting head. One that was just right. It was designed and manufactured in the lower mainland.

Now, even if the steel pipe rebounded during the splitting process, the steel pipe was still far enough away from the new pipe so as not to cause damage.
