City of Richmond Rehab - Box Culverts

By: Tonia Jurbin, P.Eng. (Retired) (for: PW Trenchless Construction Inc.)

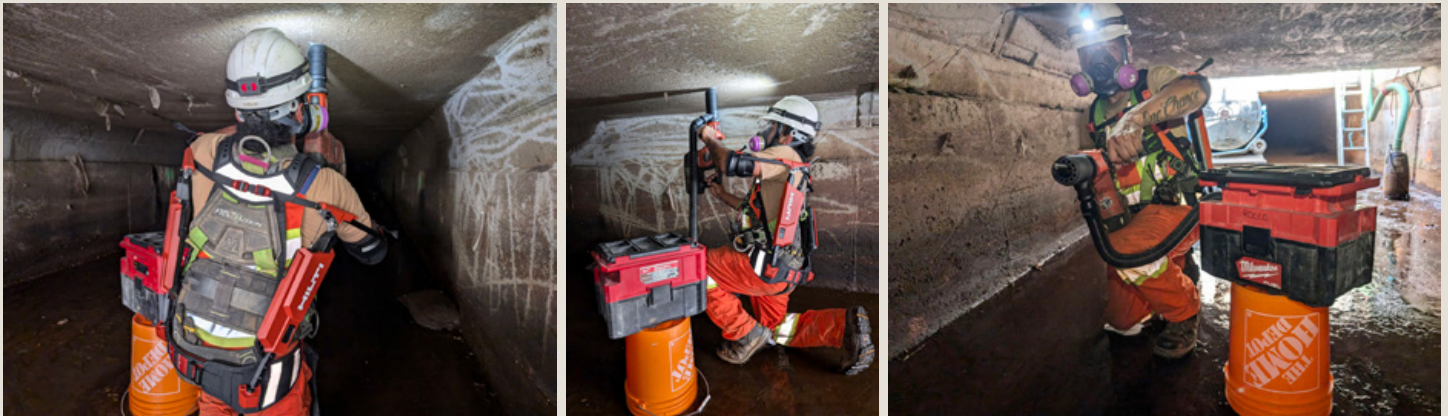
Respirator, dust suppression system and Exo Skeleton

breaking work drilling the holes in the roof of the culvert. The overhead holes were drilled from a seated or kneeling position and the workers were outfitted with EXO skeletons to assist supporting their backs, arms and shoulders. The EXO skeleton suits used weigh about 2.4 Kilograms (5.3 pounds) and cost \$1,860 CDN. All the workers rotate all the jobs, drilling, mucking, moving materials etc. There was also a dust suppression kit attached to the hammer drills and the crews were outfitted with full face respirators as well.

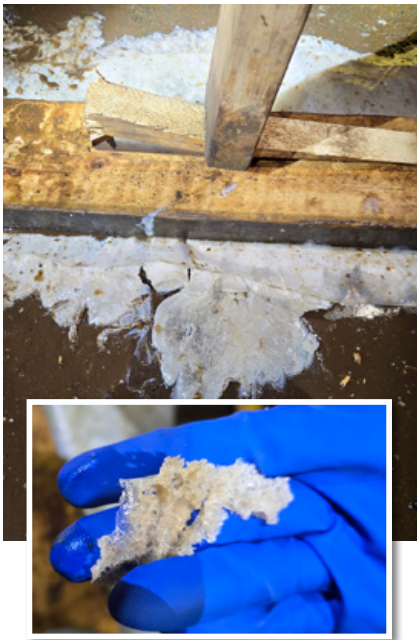
Close up of floor foam

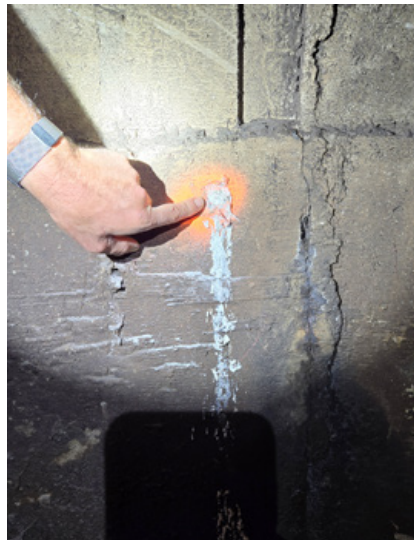
Close up of grout return

This process 'sealed' the majority of the infiltration at each joint, very few things are truly waterproof in BC's lower mainland, but the process sealed the majority of infiltration at each joint. The density of this product once cured is about 3.5 pounds/ft³ so not a major contributor to further settlement. It takes about 8 hours for a full cure but the working time is only about 35 seconds. Confirmation of the delivery is done during the application by watching for foam return in the adjacent drill holes. Some finesse is required for this work, as over-injecting can cause heave. On this project the injection was done to rejection and by watching for return from adjacent holes.

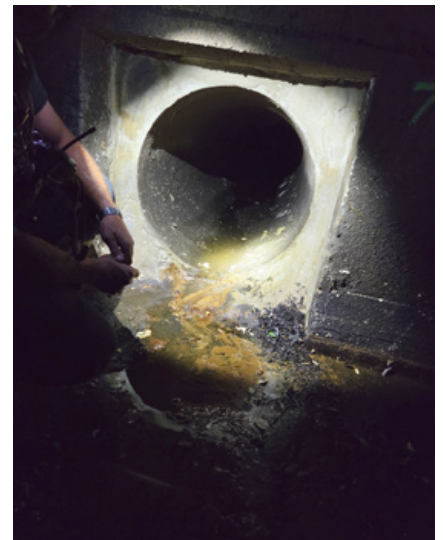
One of many service pipes into the box culvert

When Infrastruct demobilized, PW used CCTV cameras to inspect all the connecting services into the culvert. The data from this final inspection was submitted to the City for further consideration. The last step was to form the hatch lids that were cast on site, lowered into place and backfilled.

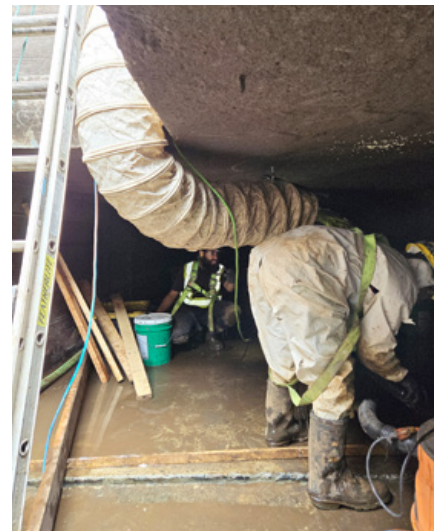
Typical Working Conditions

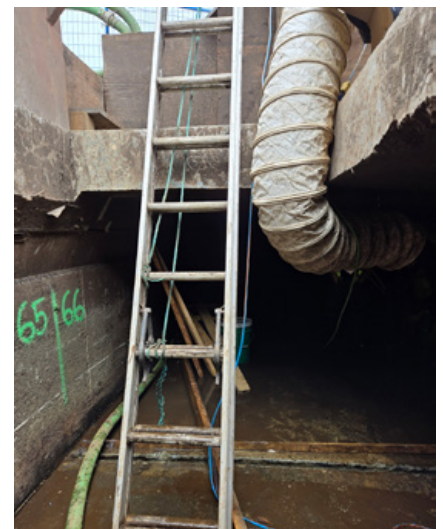
Access Hatch

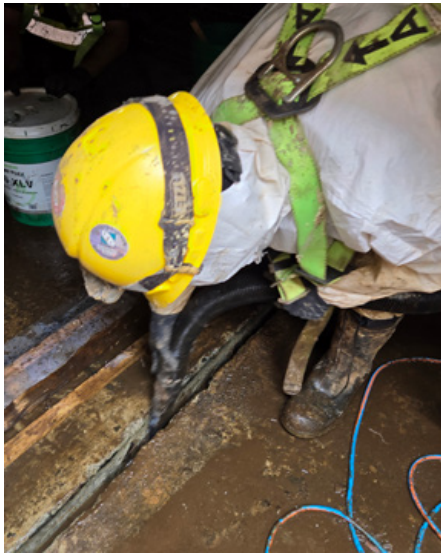
Floor joint cleaned out then stuffed with oakum

The floor joints were then stuffed with resin-soaked oakum, a modern twist on an old ship repair technique. Historically oakum was made from untwisting old ropes which were covered in tar and used as caulking, mostly for ships but also used in plumbing applications for sealing couplings. In modern times the oakum is made from hemp or jute. Again,

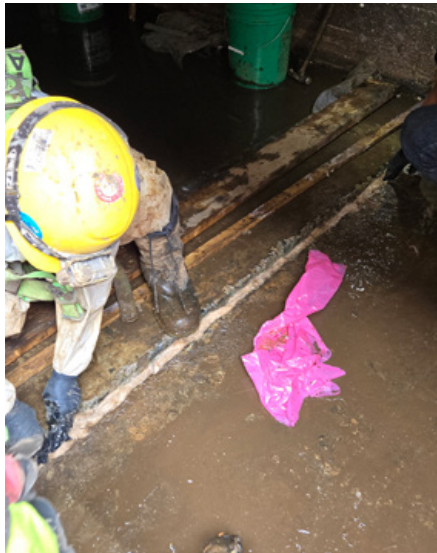
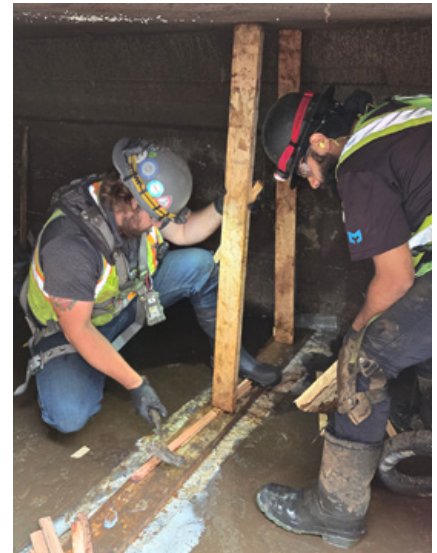
Strutting placed on floor joint after application of resin and oakum

this work has to be done quickly as the hydrophilic resin used sets in about 5 minutes. Once the joint is filled with the resin impregnated oakum the crews worked quickly to get forms on top of the joint and tighten the whole system with wedges and struts. The resin Infrastruct uses expands about 9X by volume and cures overnight. The result is a flexible adhesive gasket which is not diggable but can be cut if necessary.

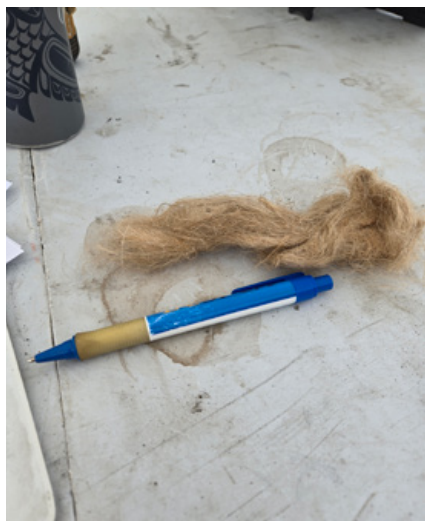
Oakum Sample

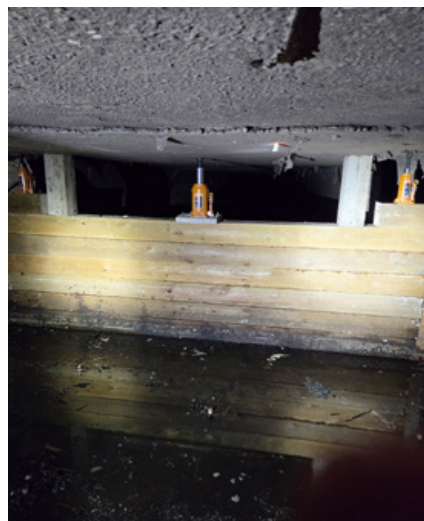
Dam at end of project

The first step was to isolate the length of the tunnel to be rehabilitated by installing dams at both ends. The next step was to clean out all the sediment using mostly high pressure water to move the material to one of the two access hatches, or one of the 15 existing manholes, and then remove it by vacuum excavation. The team removed some 50 years' worth of sediment – enough to fill about 35 hydrovac trucks.

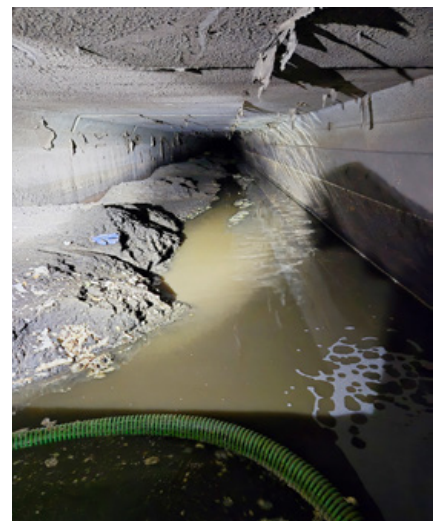
Sediment in culvert beyond the dam
