TUNNEL VISION

**A DOWN-AND-DIRTY LOOK AT
REPLACING OLD HYDRO CABLES**

With a \$24-million budget, five contracts and a duration of 18 months, replacing two underground high voltage transmission cables is keeping Vince Masek, Project Manager for BC Hydro hopping.

The total replacement job is a 3.8 km section of 230 kV cables which includes a 175 m tunnel under the Trans-Canada Highway, the exit and entry points of which are located in parks.

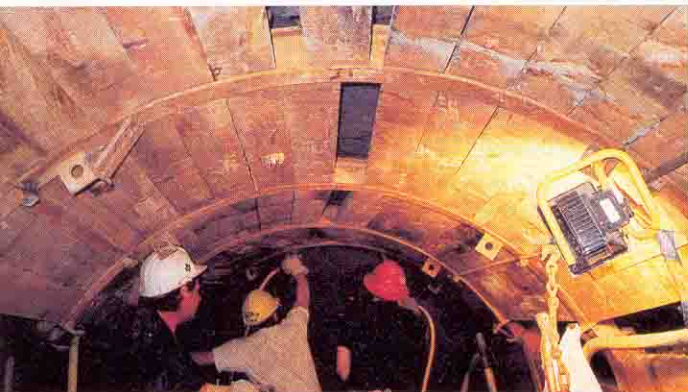
Steel beams and hardwood laggings were used through much of the tunnel.

As the tunnel advanced, the crew installed the rib sets, the three round "I" beams and hardwood timber lagging. Before the .3 m-thick concrete liner was installed over the lagging, all of the steel connector bolts on the ribs had to be replaced with Teflon rods.

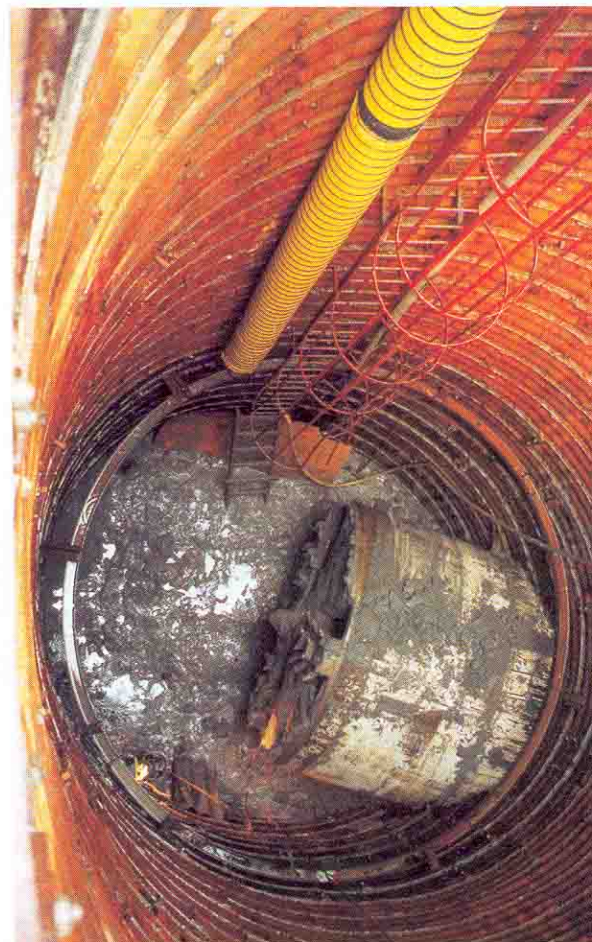
A view from above showing TBM nose at exit shaft.

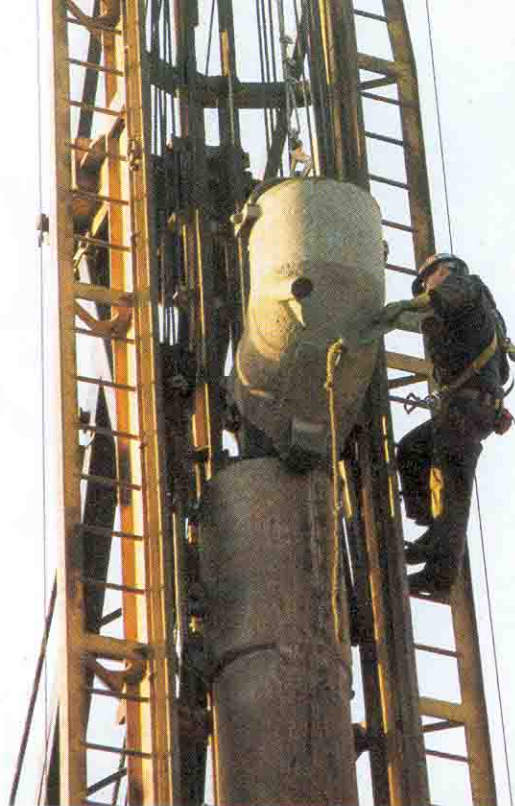
Worker releases gravel into one of the jobs many caissons.

Once in place, gravel was dropped into the pile and compacted with a very heavy hammer dropped from 5 m. That caused the gravel to bridge in the bottom of the pile. The pile was advanced down to competent soils by hammering on the gravel plug, and the stone columns were built to the surface by continually dumping gravel into the top of the pile while at the same time raising the

Each bucket of gravel has to be handled several times by a loader, and a worker has to climb the leads to dump every bucket. About 800 m³ of gravel went into building 360 stone columns at the Hill Avenue Terminal Station on the north side of the highway. The area imme-

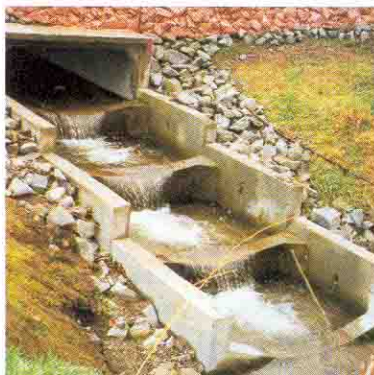
Building a fish ladder was just one of the challenges.

plete with nine water crossings, a modern fish ladder, and a bridge to span the 0.9 m Greater Vancouver

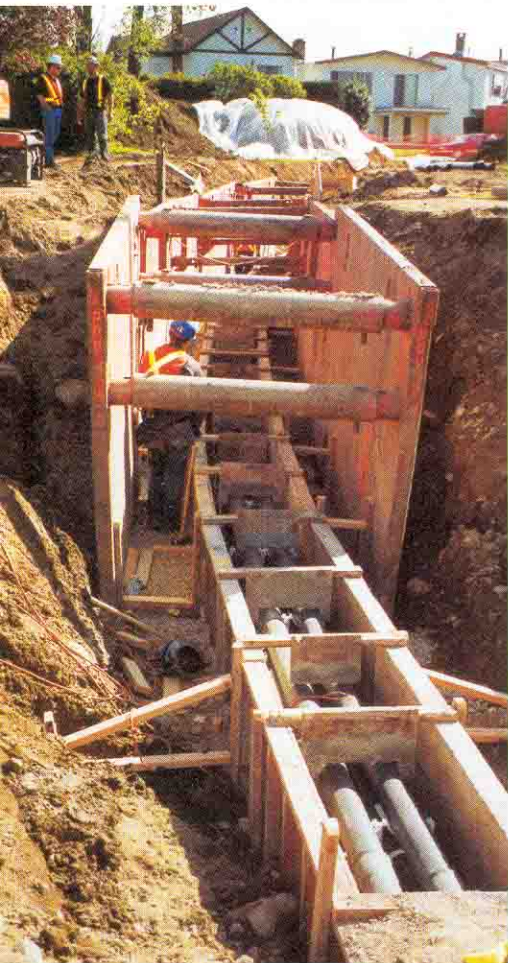
Duct repairs at an intersection along the route.

At least 30 repairs or replacement sections were built for each of the two ducts. BC Hydro crews did about 50% of the ductwork repairs, while Kingston Construction Ltd.
